Case Study: Dynamic Performance Enhancement of Power Substation Reactor Foundations through Vibration Analysis and Self-Leveling Concrete Retrofitting

Keywords-case study; heat map analysis; self-leveling concrete; reactor foundation

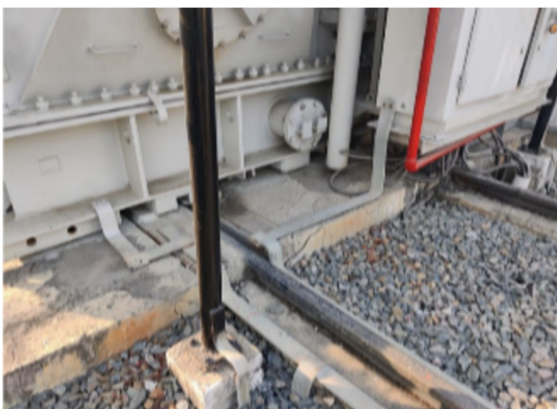
Fig. 1. Reactor foundation, front view with cracks.

The 80MVAR reactor foundations exhibited significant cracking, presenting important operational and structural safety concerns for the substation and associated transmission infrastructure. More specifically, the foundations exhibited a top uneven surface and crack formation. Most cracks were concentrated at the structural steel–concrete interface (Figures 1 and 2). Field measurements revealed that cracks demonstrated widths ranging from 3 to 4 mm and penetration depths between 500 mm and 650 mm. Diagnostics showed that the reactor-induced vibrations and localized stress concentrations caused surface unevenness, initiating cracks and driving their progressive propagation.

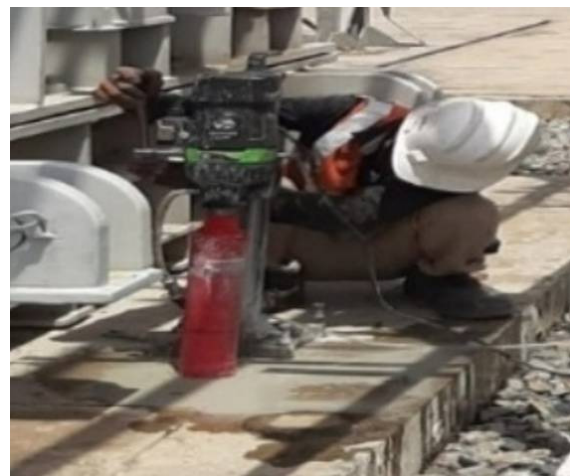
Fig. 3. Core extraction.

To evaluate the compressive strength of the foundation core, samples were extracted (Figure 3) from randomly selected locations while avoiding reinforcement zones to ensure reliable sampling (Table I). The results confirmed that concrete quality remained satisfactory (Figure 4, Table II), indicating adequate structural integrity. All testing procedures adhered to [5].

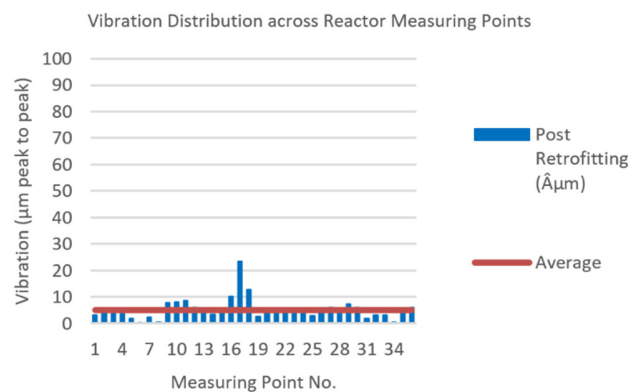
Fig. 10. Maximum and average vibration post-retrofitting.

Post-retrofitting evaluation at 40 points showed a 40–60% reduction in peak-to-peak displacement, with average vibration decreasing from 23.36 μ m to 4.98 μ m and maximum vibration from 95 μ m to 23.31 μ m, indicating significantly improved stiffness and dynamic performance. (Figures 9-12).
