Corrosivity Evaluation of Copper-Nickel Alloy (90/10) in Pumps Used in Offshore Platforms for Seawater Pumping

Abstract—This work discusses the case of corrosion in a copper-nickel alloy used in seawater, where chlorination is necessary to control micro- and macro-organism growth that can render inoperable the seawater supply system used in an offshore platform. Studies developed in the last 30 years have shown copper-nickel's adequateness in seawater, with a corrosion rate of about 0.001mm/year. However, annual equipment inspection showed localized corrosion in an internal chamber in a stand-by pump. Such corrosion occurred due to high-concentration of sodium hypochlorite (NaClO) injection into the operational system, even for pumps that were out of operation. To evaluate this corrosive process, gravimetric (mass loss) and electrochemical tests were developed in synthetic seawater with NaClO at concentrations of 100, 500, 1000 and 5000mg/L. The results indicated that the corrosiveness varied from low to moderate. The presence of pitting and crevices observed in the laboratory tests derails or compromises material use in seawater. It was concluded that there is a need for continuo

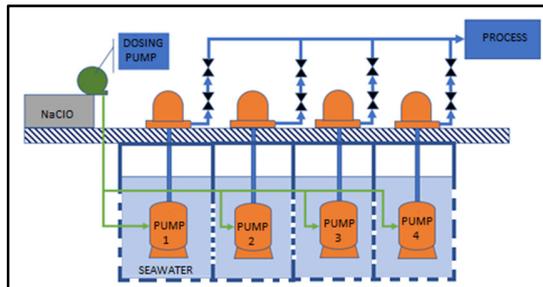
Fig. 1. Diagram of pump intake and seawater transfer

in a considerable increase of concentration of NaClO in the inner chamber, while on the outside of the pump (casing), in contact with sea water and without the presence of NaClO, localized corrosion or pitting were not observed. It is important to note that in the deposits removed inside this pump (in stand-by) no micro or macro organisms that could cause a microbiologically influenced corrosion (MIC) were identified due to the high concentration of chlorine due to NaClO accumulated inside this pump. Figures 2 and 3 present a view of the seawater suction pump and the dosing pump hypochlorite injection.

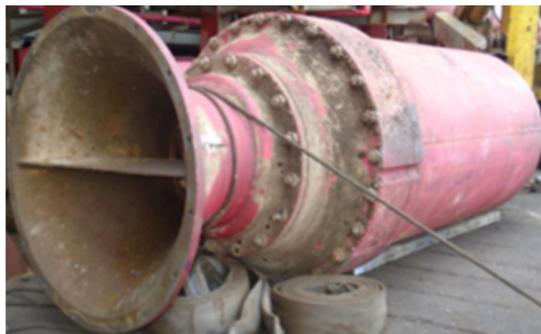
Fig. 2. Seawater suction pump

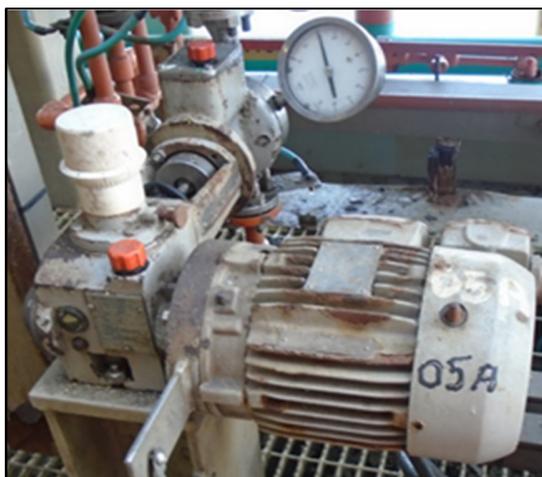
Fig. 3. Hypochlorite injection dosing pump

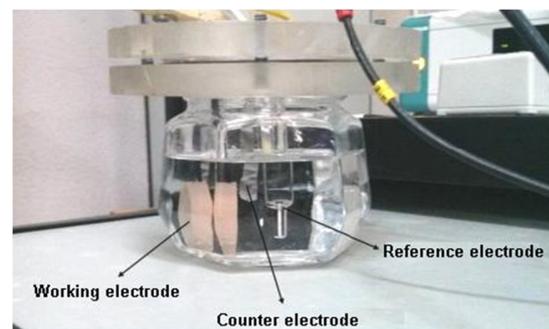
For the polarization measurements, samples of the copper-nickel alloy were cut in order to obtain an electrode surface of 0.20cm². The metal surface was then embedded in polyester resin and polished with No. 600 emery paper. Then, the samples were degreased with acetone and washed in distilled water before being inserted in a conventional polarization cell, as shown in Figure 4.

Fig. 4. Conventional polarization cell

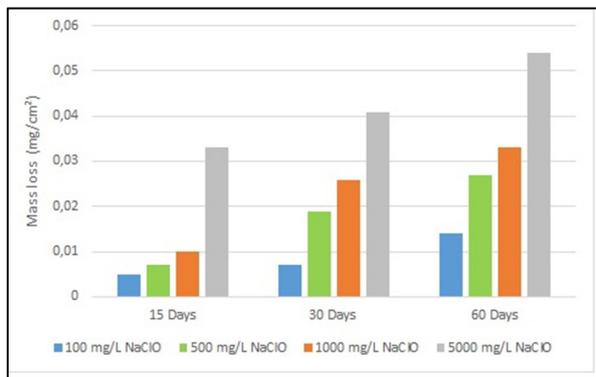
The test results of the weight loss of copper-nickel alloy coupons in the saline solutions with 100, 500, 1000 and 5000mg/L sodium hypochlorite, 10% (by mass) are presented in Figure 5.

Fig. 5. Mass loss of copper-nickel alloy in saline solution with NaClO, average of three coupons

The mass loss assays (Figure 6 and Table I) showed that the increase in NaClO in the saline solution and the immersion time promoted the loss of mass copper-nickel alloy, meaning that the corrosion rate can be considered to be low to moderate, based on Table II as proposed by [6]. Figure 6 shows the copper-nickel alloy coupons after immersion tests in saline solution with 5000mg/L NaClO at 15, 30 and 60 days. In these coupons, localized corrosion can be observed after the removal of corrosion products. Figures 7 and 8 show other aspects of the corrosion deposits, pitting and crevice corrosion, in copper-nickel alloy coupons immersed in a saline solution with 5000mg/L sodium hypochlorite.

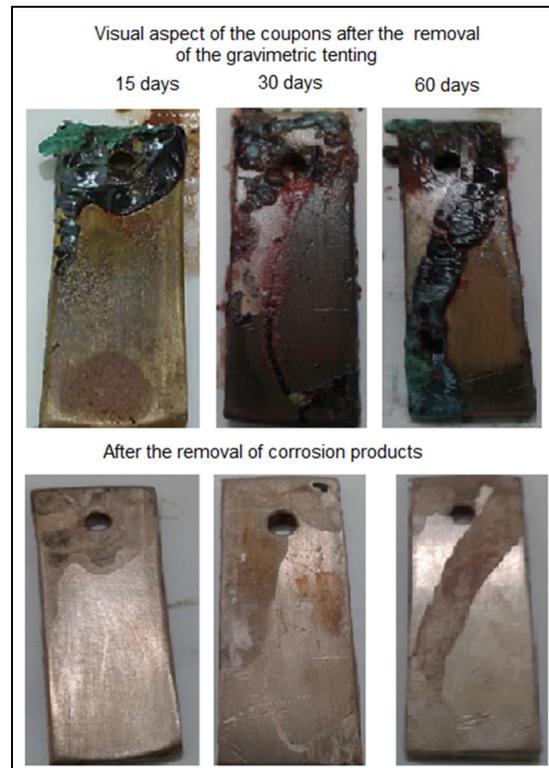
Fig. 6. Copper-nickel alloy coupons in gravimetric testing in saline solution with 5000mg/L sodium hypochlorite

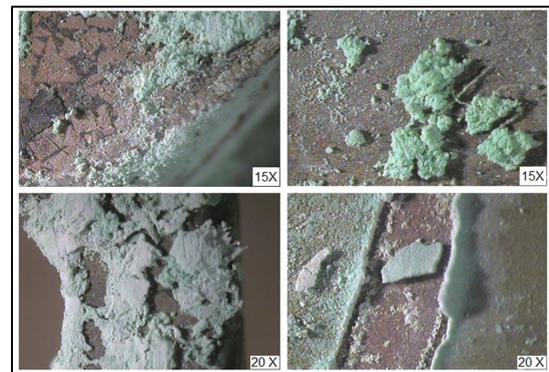
Fig. 7. Corrosion product of copper-nickel alloy coupons with 5000mg/L of sodium hypochlorite

X-ray diffraction analysis of the corrosion deposits on the surfaces of the coupons showed the predominance of copper chloride hydroxide (Cu₂(OH)₃Cl) and small amounts of copper chloride (CuCl₂) and nickel chloride (NiCl₂). According to [7], for copper in pure water during the primary corrosion reaction,

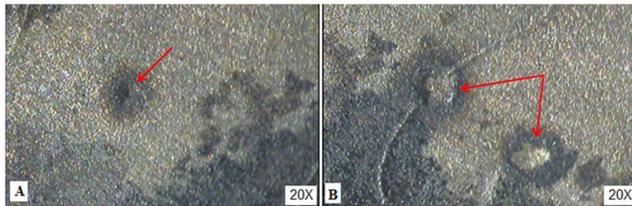
Fig. 8. Pitting (A) and crevice (B) corrosion in copper-nickel alloy coupons with 5000mg/L of NaClO

Authors in [8, 9] report that in salt solutions, with oxygenation and the addition of oxidizing substances, cuprous oxide can initially react to form multilayer structures, for example, basic copper chloride to CuCl_2 , $\text{Cu}(\text{OH})_2$ or $\text{Cu}_2(\text{OH})_3\text{Cl}$. These products do not adhere well to the surface and can be easily removed. According to [10], depending on the concentration of free chlorine in the form of NaClO, the corrosion rates of copper-nickel alloys saline solution are in the range of 0.07 to 1.27 mm/year.

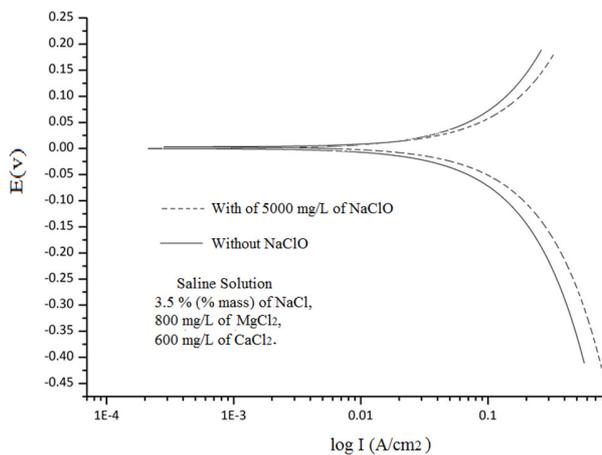
In Figure 9, polarization curves were only placed for assays with and without 5000mg/L NaClO. The curves for solutions with concentrations of 100, 500 and 1000mg/L were superimposed and were not significantly different from the curve for the solution without NaClO. The anodic and cathodic reactions are affected by the addition of NaClO. The intersection of the anodic and cathodic curves showed an increase in the intensity of current ($\log I$, A/cm^2).

Fig. 9. Current density-potential curves of copper-nickel alloy with and without addition of sodium hypochlorite

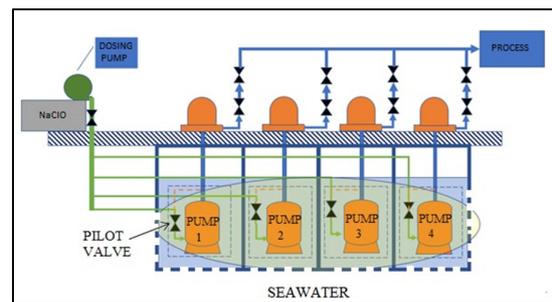
Fig. 10. Modification proposal for of seawater pumps

- Corrosion in the interior of the pumps was due to continuous NaClO injection, even when the pump was completely stopped.
- Modification of the project with installation of pilot valves monitoring the injection of NaClO could prevent corrosion of copper-nickel pumps.
