Reinforcement and Restoration Studies of the Edremit Ataturk House

Abstract—Edremit Ataturk House has been restored under the international restoration principles. Due to its importance, a systematic study was carried out to prevent the building from suffering damage. The current situation of the building was investigated by using slightly destructive and non-destructive test methods. Flat-jack and shear tests were used in order to identify the mechanical properties of masonry walls according to the ASTM standards. The operational modal analysis test method was used in order to understand its dynamic characteristics. After the diagnosis phase, a finite element model was prepared and calibrated according to the in-situ test results. The reinforcement studies were performed according to the finite element modal analysis results. Finally, the differences between the dynamic properties of the structure were evaluated by vibration tests before and after the restoration works.

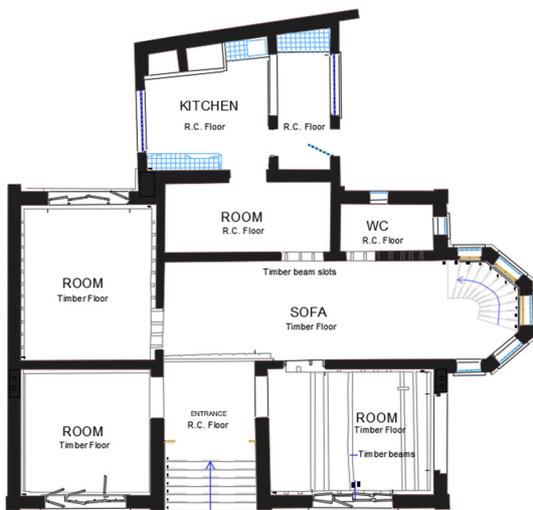
Fig. 1. The first floor plan view

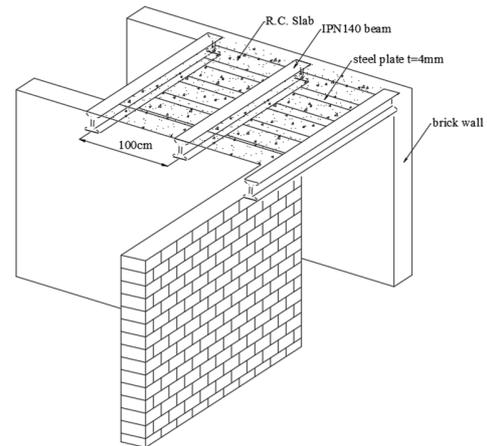
The building's approximate dimensions are 14m×10m. All exterior and interior walls were built with solid bricks and lime mortar as a binding material. Solid brick dimensions are 5.5cm×11cm×24cm. The basement floor was used as storage. The living spaces (sofa, rooms, kitchen, toilet and bath) were in the first and second floor. The basement floor height is 2.10m, while the first and second floor heights are 3.50m. The outer walls are 50cm thick. The interior walls were 45cm in the basement, 30cm in the first floor and 25cm in the second floor. The walls were plastered with lime mortar. The section of timber beams were 6×15, 6×10, and 6×12cm. The slabs of the wet spaces were arranged as reinforced concrete. Reinforced concrete slabs are formed on the masonry walls in this type of construction [7]. Only the slab in the entrance part of the building is different from the other Reinforced Concrete (RC) slabs. In this part, the RC slabs were supported by IPN140 beams. Timber and RC slabs on the first-floor plan view can be seen in Figure 1. The timber floor and RC slabs were constructed at the same time because there are no construction joints at the intersection of the walls, and the floor elevations are equal. Despite the fire, the RC slabs are intact today. The RC slabs and the timber beams used in the construction of the building are shown in Figure 2. The detail of the RC slab in the entrance of the building which is supported by IPN140 beams can be seen in Figure 3.

Fig. 3. The detail of the RC slab in the entrance of the building

The timber beams were arranged between the first and second floor walls (Figures 11-12). Local deteriorations occurred under the RC slab which was located in the entrance of the building. The IPN140 beams and metal plates between the RC slabs were corroded. Grout was used under the RC slab for the deteriorations. The IPN beams and the metal plates were protected against corrosion by using anticorrosion paint (Figure 13). After the reinforcement and the restoration of the house, in-situ vibration tests were performed again. The sensor placements were the same with the previous tests which were performed before the restoration studies. The values of the spectral densities of the test are shown in Figure 14. These values show us that the frequencies of the house changed. The first frequency of the house was increased by 15% due to the completion of the timber beams and the roof of the house.

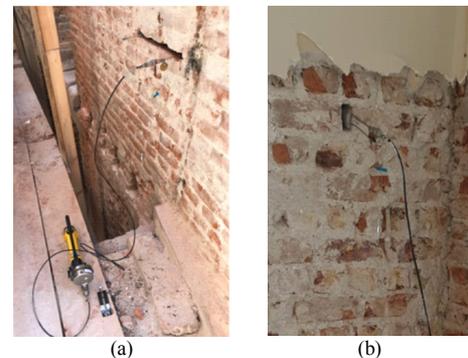
Physical and mechanical properties were investigated by laboratory and in-situ tests. Compressive stress, shear stress, and elastic moduli of walls were identified by using flat-jack and shear test methods. A double layered thin plate called as flat-jack was inserted in a cut slot of the mortar. Hydraulic oil pressure was inflated into the flat-jack and displacements were continuously monitored (Figure 4(a)). The tests were performed and calculations were done according to ASTM C1197 and ASTM C1314 [8, 9]. In shear test, the flat-jack is horizontally inserted at one end of the test unit and the oil pressure was inflated into the flat-jack until the slip of the mortar (Figure 4(b)). Method C was performed in shear test according to ASTM C1531-09 [10].

Fig. 4. Mechanical tests: a) Flat-jack test, b) shear test

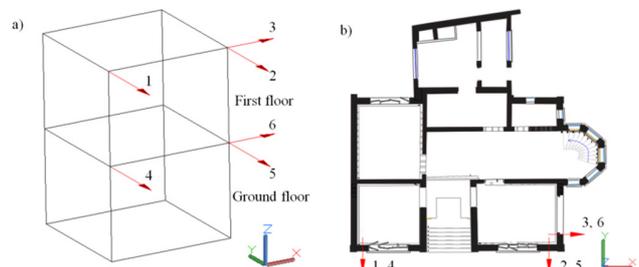
The PSD matrix rank is equal to the multiplicity number of the modes in case of repeated modes. The modal frequencies can be calculated by the peaks of the singular value plots. The corresponding singular vectors give the mode shapes. [13]. Testbox 2010 series data acquisition system was used [14]. Six monoaxial accelerometers were placed at the first and second floor of the building for the test. The orientation of sensors was carefully checked to ensure they were perpendicular to each other. The placement of the sensors in perspective view and plan view are seen in Figure 5. The singular values of the spectral densities of all the test setup are shown in Figure 6.

Fig. 5. The placement of sensors: a) perspective view, b) plan view

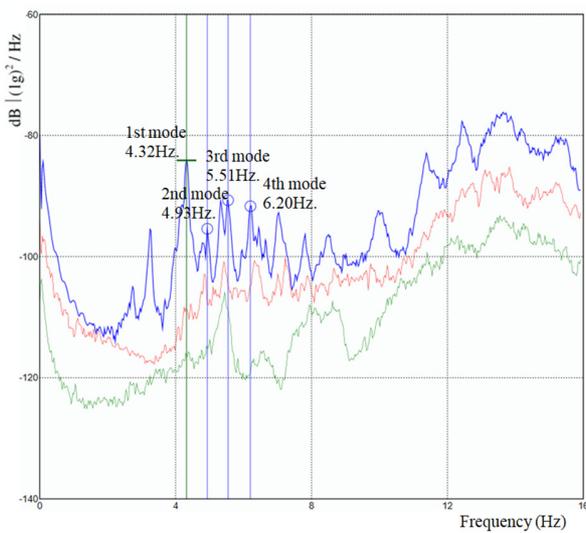
Fig. 6. The singular values of the spectral densities

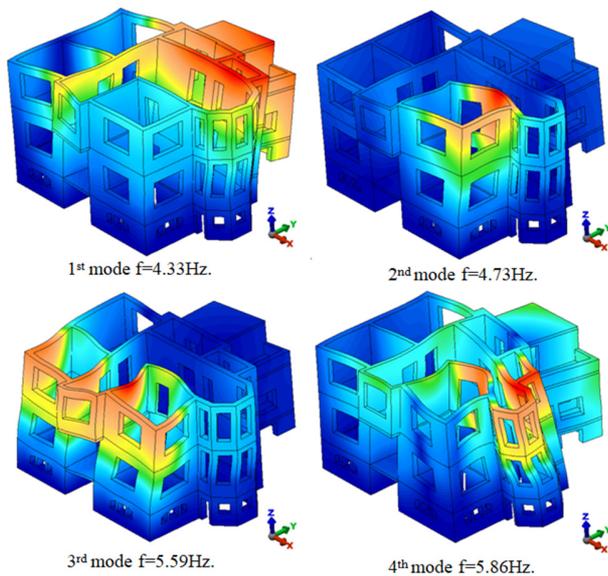
Finite element analysis was performed with Algor V20 finite element analysis program [15]. The solid elements were three-dimensional and generally 8-noded brick type with three degrees-of-freedom at every node. The material properties of the brick walls were obtained from the test results. In the finite element mesh, 15964 solid elements were used. Natural frequencies, mode shapes and mass participation factors were obtained from the modal analysis. The natural frequencies obtained from modal analysis were compared with the in-situ vibration test results and the calibrations were made until the errors were less than 10%. After the calibrations, the elastic moduli of the walls were taken with an average of 2250N/mm² with an 18% error between the flat-jack test results. The reason for this is the small number of field tests. More accurate results will be achieved as the number of tests increases. The first four mode shapes and the frequencies are presented in Figure 7.

Fig. 7. The first four mode shapes and frequencies: 1st mode: displacement in y direction, 2nd mode: torsion, 3rd mode: displacement in x direction and 4th mode: torsion

Out-of-plane movements were observed on the first and second floor walls according to the mode shapes of the building. There were no out-of-plane movements observed on the walls constructed with reinforcement concrete slabs except the roofless walls. After the restoration works, the construction of the timber floors and the roof system reduced these movements to some extent. However, timber slabs cannot provide as much rigidity as reinforced concrete floors. Therefore, before the timber slab constructions, the walls were strengthened in order to reduce the out-of-plane movements of the first and second story walls. In the reinforcement of the walls a textile product with an appropriate bonding plaster was used. The reinforcement of the walls and the textile product can be seen in Figure 8.

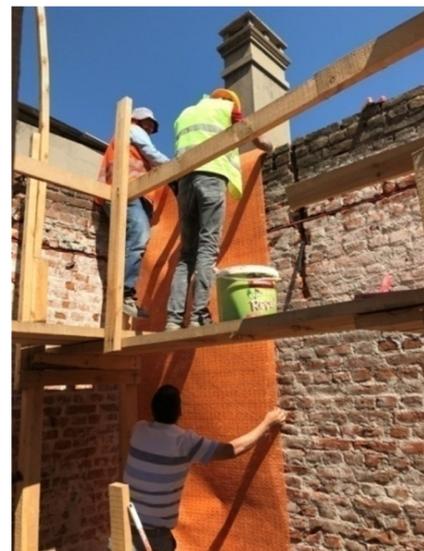
Fig. 8. The reinforcement of brick walls

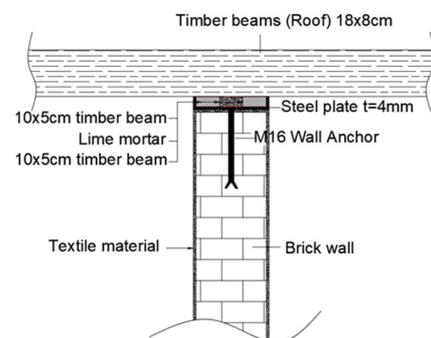
Fig. 9. Details of the timber beams on top of the walls

supported on top of the walls by steel plates with anchorage (Figure 9). In Figure 10 we can see the timber beams arranged on the top of the walls. The roof of the house was finished after the reinforcement of the brick walls.

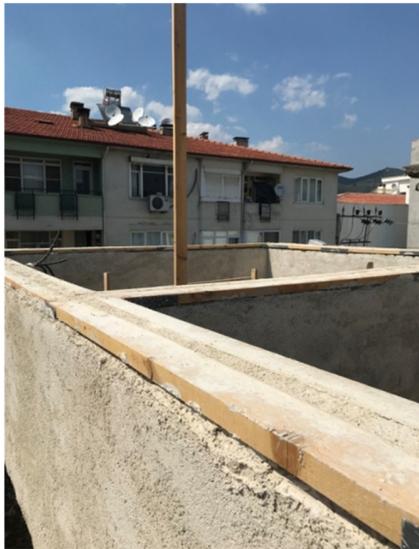
Fig. 10. The timber beams arranged on the top of the walls

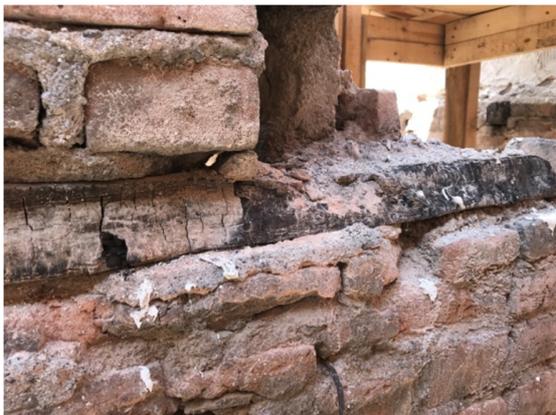
Fig. 11. A timber beam which was burned in 1991

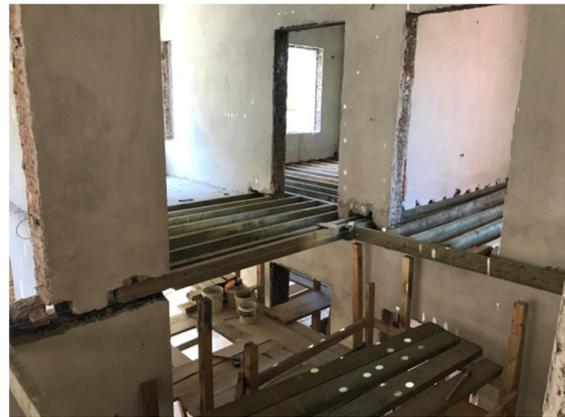
Fig. 12. Timber beams arranged between the walls

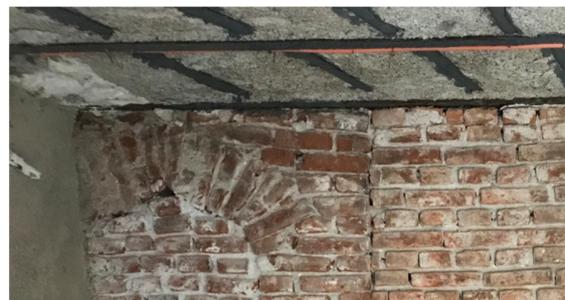
Fig. 13. The reinforcement of the R.C slab in the entrance of the building

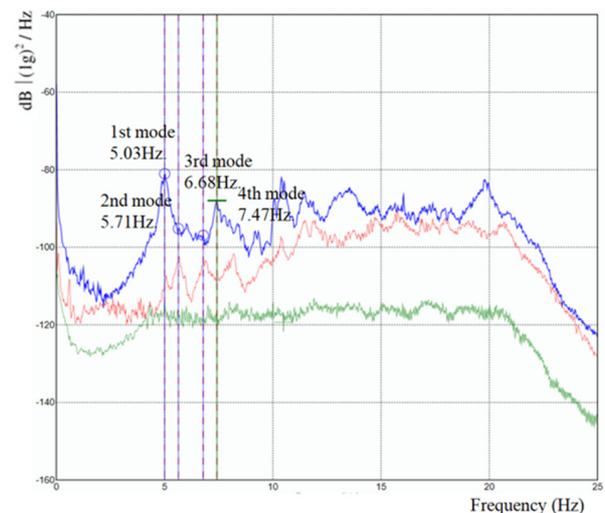
Fig. 14. Singular values of the spectral densities (after restoration)
